**IN THE MATTER OF THE DEATH OF A FEMALE
AND THE INJURY OF A MALE
IN THE COURSE OF AN ATTEMPTED TRAFFIC STOP
BY MEMBERS OF THE RCMP
IN SICAMOUS, BRITISH COLUMBIA
ON MAY 20, 2021**

**DECISION OF THE CHIEF CIVILIAN DIRECTOR
OF THE INDEPENDENT INVESTIGATIONS OFFICE**

IIO File Number:

2021-126

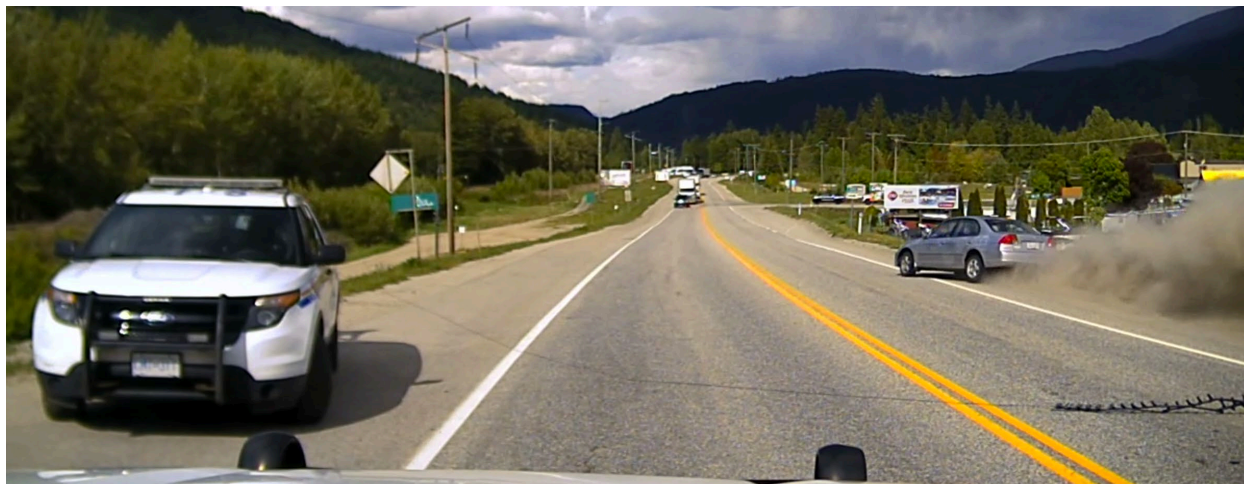
The screen shot below is taken from the Watchguard dash camera video system in WO2's police vehicle. On the left is SO's vehicle. SO has retreated behind it at this point, pulling the cord that extends the spike strip, which can be seen partially across the eastbound lane. The Honda can be seen swerving back from the shoulder onto the pavement with its driver side tires impacted by the spikes.

It was subsequently determined that the Honda had been reported stolen, and a number of different licence plates were found in and around the vehicle. It was mechanically inspected and an improvised repair to the brake system was noted that would have negatively impacted braking performance. Both driver side tires were found to have spikes from the police spike belt embedded in them. The hollow spikes are intended to

produce a relatively slow deflation of the affected tire(s), so that if the Honda had not gone out of control and crashed, the driver side tires would likely have been running flat within approximately one kilometre. It is unlikely that picking up the spikes, in itself, would have caused the Honda to crash.
