**IN THE MATTER OF THE DEATH OF A FEMALE  
AND THE INJURY OF A MALE  
IN THE COURSE OF AN ATTEMPTED TRAFFIC STOP  
BY MEMBERS OF THE RCMP  
IN SICAMOUS, BRITISH COLUMBIA  
ON MAY 20, 2021**

**DECISION OF THE CHIEF CIVILIAN DIRECTOR  
OF THE INDEPENDENT INVESTIGATIONS OFFICE**

2021-126

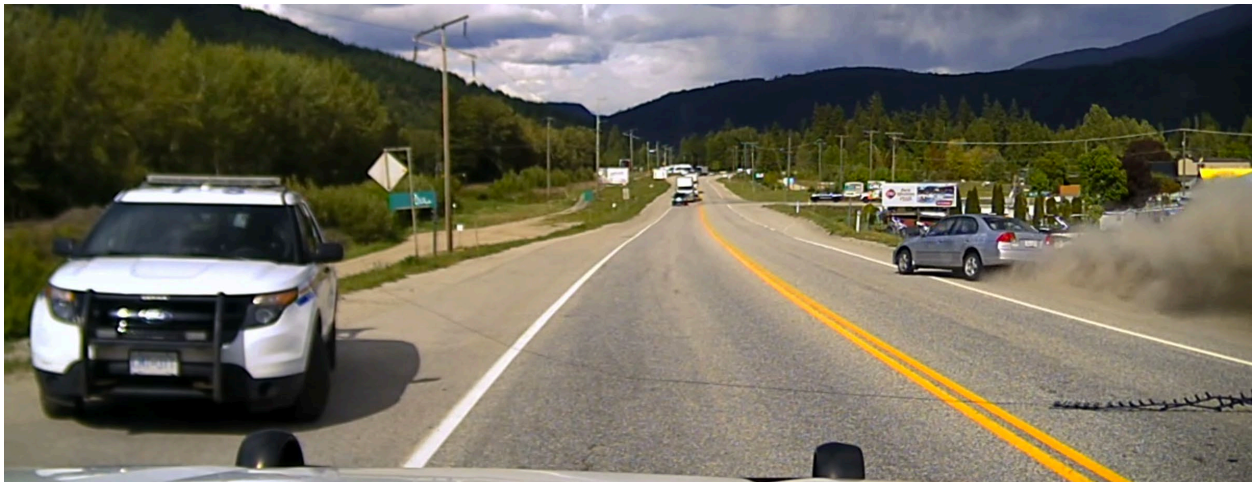
The screen shot below is taken from the Watchguard dash camera video system in WO2's police vehicle. On the left is SO's vehicle. SO has retreated behind it at this point, pulling the cord that extends the spike strip, which can be seen partially across the eastbound lane. The Honda can be seen swerving back from the shoulder onto the pavement with its driver side tires impacted by the spikes.

It was subsequently determined that the Honda had been reported stolen, and a number of different licence plates were found in and around the vehicle. It was mechanically inspected and an improvised repair to the brake system was noted that would have negatively impacted braking performance. Both driver side tires were found to have spikes from the police spike belt embedded in them. The hollow spikes are intended to

produce a relatively slow deflation of the affected tire(s), so that if the Honda had not gone out of control and crashed, the driver side tires would likely have been running flat within approximately one kilometre. It is unlikely that picking up the spikes, in itself, would have
